**FOUNTAIN OFFSHORE  
BOAT RESTORATION**

**NANO-CLEAR® INDUSTRIAL COATING FOR THAT'S MINOR CUSTOMS RESTORATION**

**Project:**  
Restoration of a Fountain Offshore boat using Nano-Clear® Industrial (NCI) for increased UV protection and reduced maintenance.

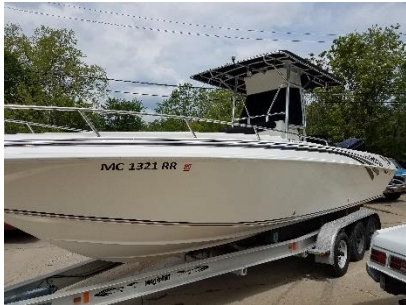
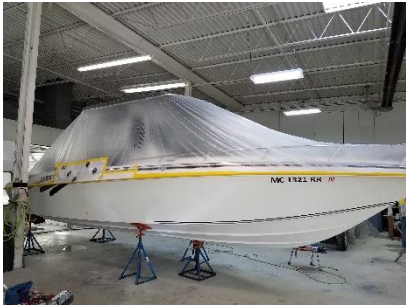
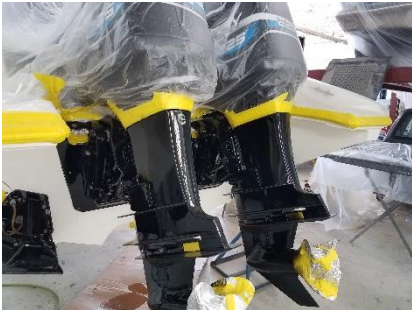
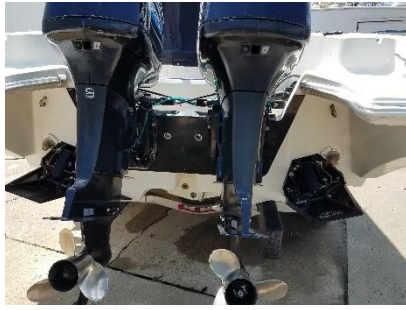
**Before and After Restoration of a Fountain Offshore Boat using NCI**

**PROJECT OVERVIEW:**  
That's Minor Customs received a Fountain offshore boat with sun damaged paint, hull staining from algae and microbial bacteria resulting in an overall degraded external condition. That's Minor Customs was contracted to restore the exterior of the boat to a like-new condition. The boat was prepared per standard practices, removing zebra mussels, algae staining, and other organic materials, fixing cosmetic flaws, in preparation for touchup paint and a final NCI coating. The protocol for NCI coating was followed for this project.

**RESULTS:**  
The exterior of the boat was fully restored with a protective NCI coating that provides it with over 10 years of UV and corrosion protection.
